NBSIR 82-2509

Corrosion Evaluation of Underground Telephone Cable Shielding Materials

June 1982

J. L. Fink, E. Escalante, and W. F. Gerhold

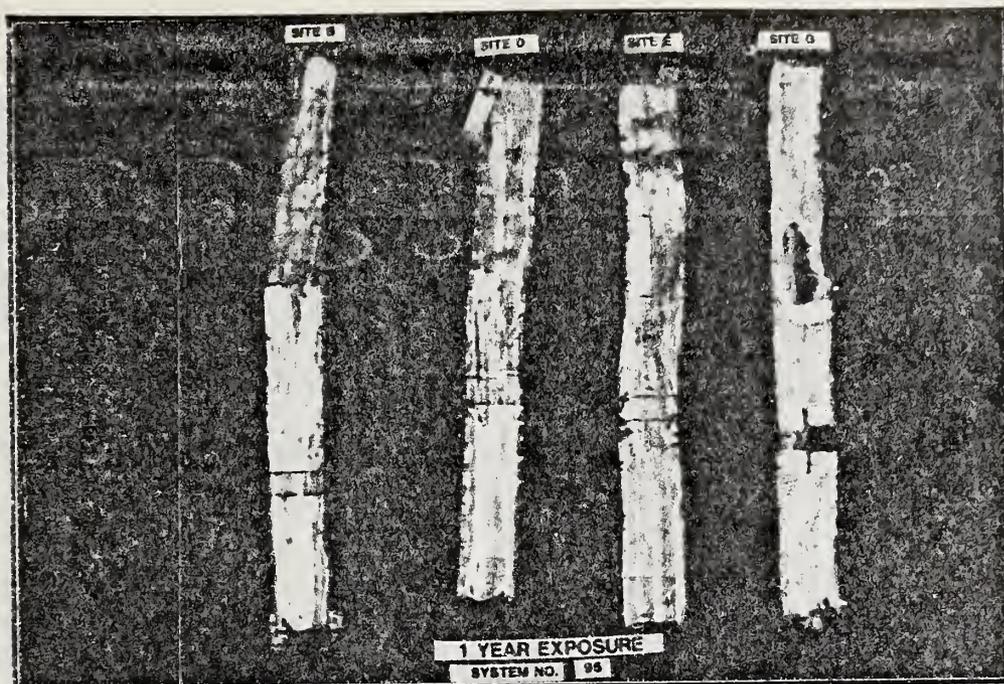
Figure 2. Outer Shield; System 95, Sites B,D,E, and G, left to right, exposed for one year. Severe corrosion at the window and ring areas on the specimen from Site G.

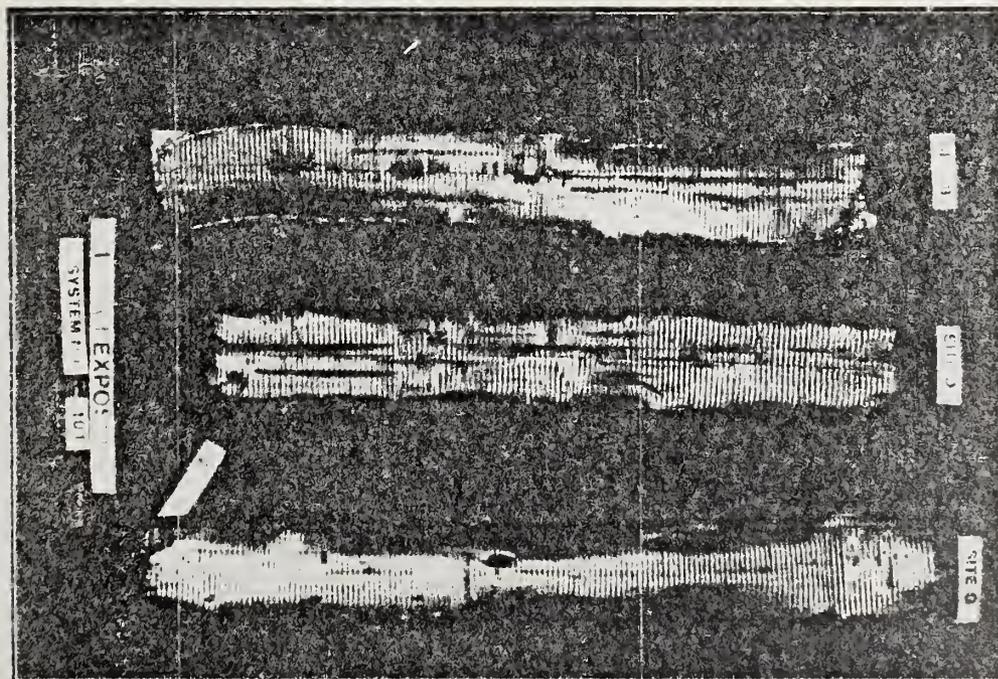
Figure 3. Outer Shield; System 101, Sites B,D, and G, top to bottom, exposed for one year. Dark areas indicate corrosion at the window and ring areas on the specimen from Site G.

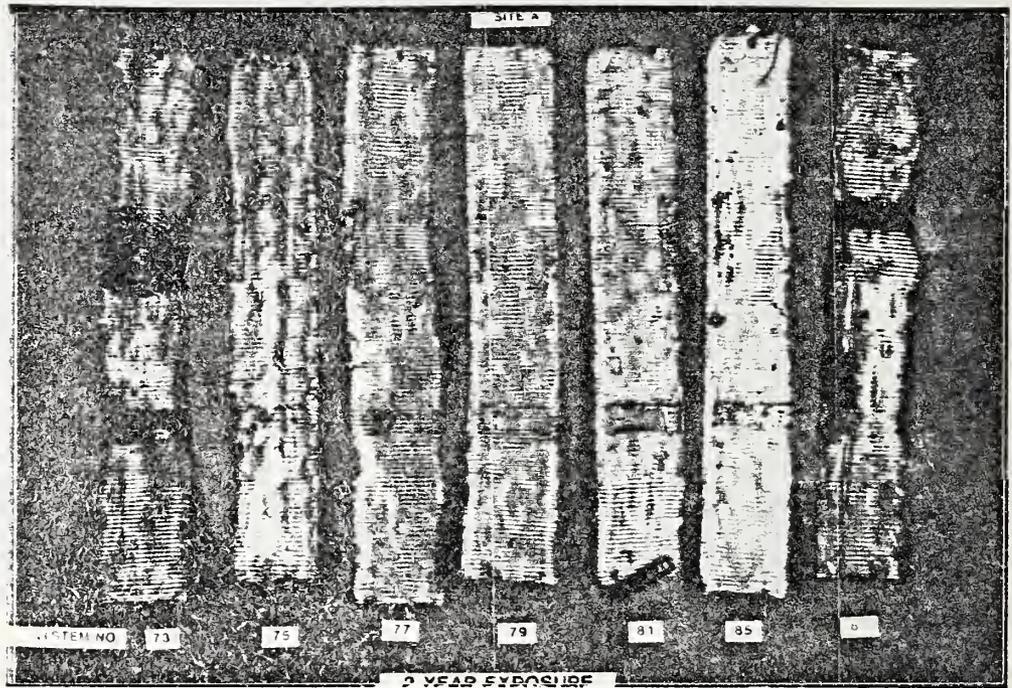
Figure 4. Outer Shield; Systems 73,75,77,79,81,85, and 87, left to right. Exposed at Site A for two years. Dark areas on specimens indicate corrosion.

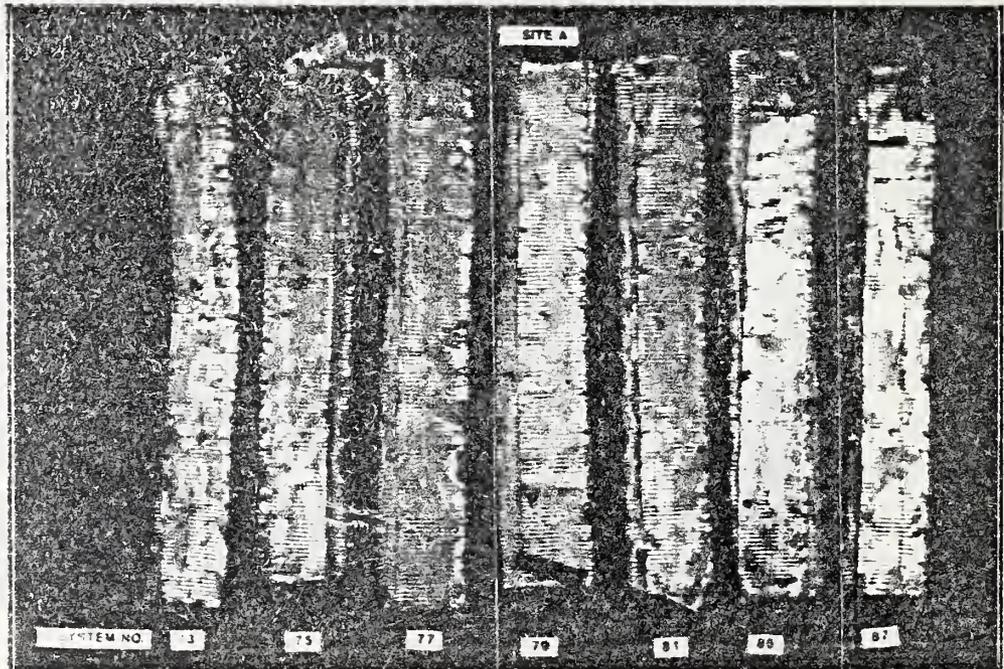
Figure 5. Inner Shield; Systems 73,75,77,79,81,85, and 87, left to right. Exposed at Site A for two years. Corrosion was not apparent.

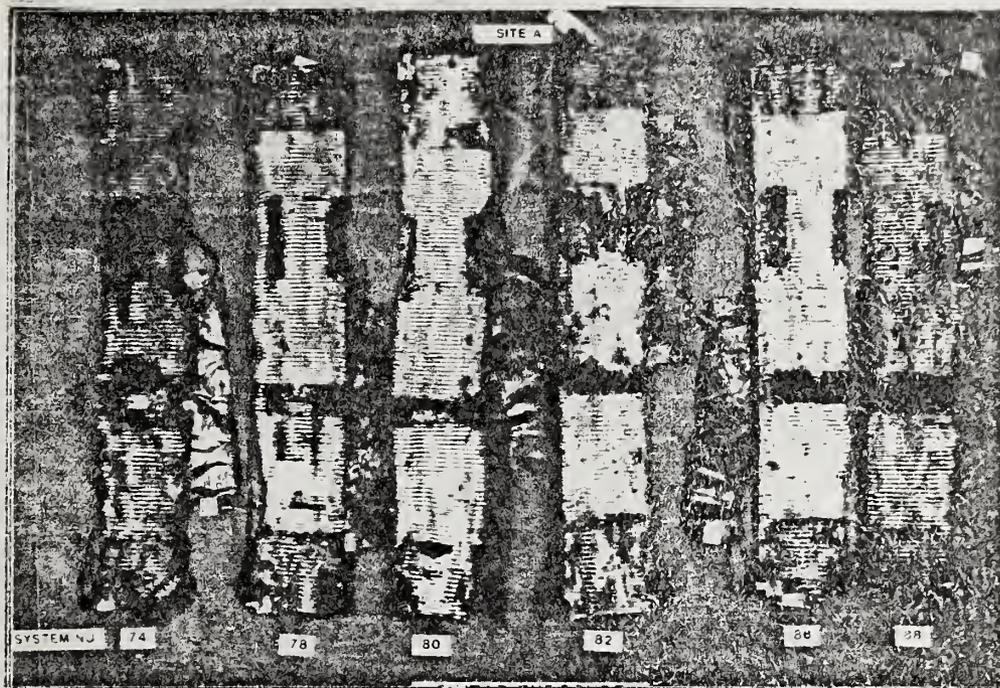
Figure 6. Outer Shield; Systems 74,78,80,82,86, and 88, left to right, exposed at Site A for two years. Dark areas on specimens indicate corrosion. Coupling this system to copper accelerated corrosion.

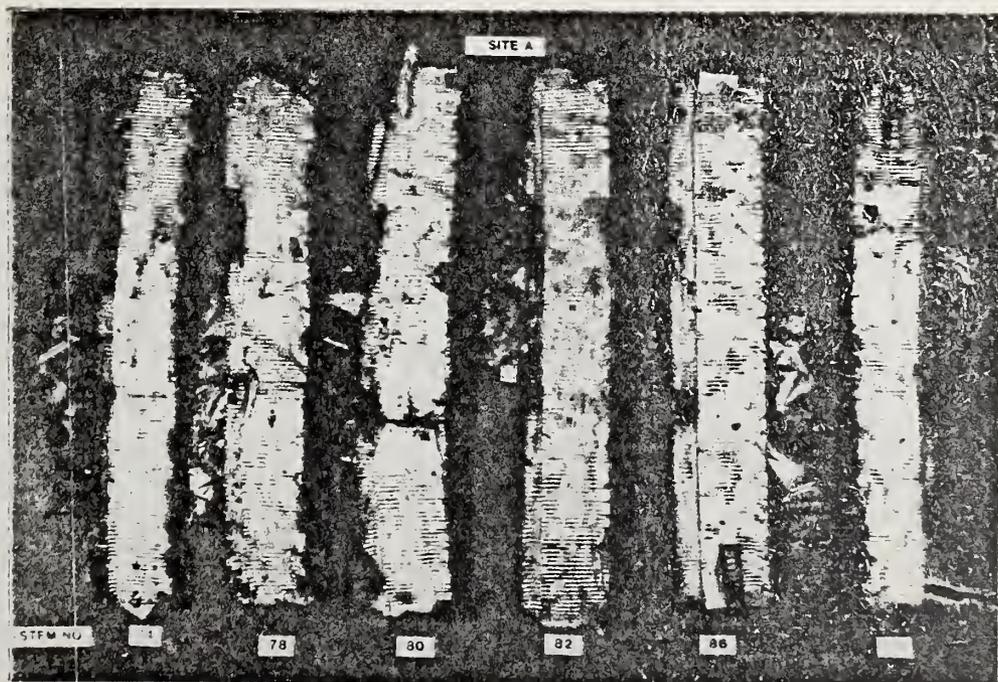
Figure 7. Inner Shield; Systems 74,78,80,82,86, and 88, left to right, exposed at Site A for two years. Degradation on System 80 and 82 at the window and ring areas.

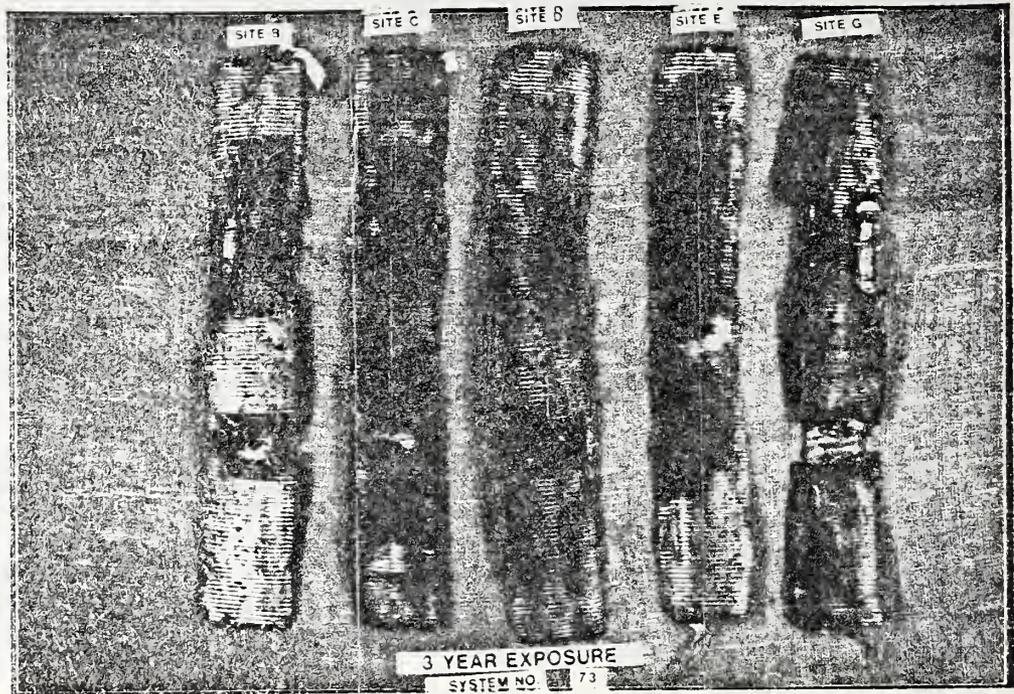
System 73. In general, the inner and outer shield of specimens of this system (Table 1) exposed for one year at all sites were unaffected by corrosion. Degradation of the outer black plate steel shield was severe at the unjacketed window and ring areas on the specimen buried at Site B for up to three years. The shield was near ELD at the unjacketed ring area for specimens buried for three years. The outer shield of specimens exposed at Site A for two years and at Sites C and D for two and three years was severely corroded at the unjacketed window and/or ring areas. Perforation due to corrosion at the window areas of the outer shield of specimens exposed for two years at Site E was noted. In general, the inner aluminum alloy shield was unaffected by corrosion except at Site G where ELD or near ELD was observed at or adjacent to ring areas on specimens exposed for three years. The outer shield exposed for three years at Site G was ELD at all areas examined, except for the jacketed areas.

Figure 8. Outer Shield; System 73, Sites B,C,D,E, and G, left to right, exposed for three years. Specimens from Sites B,C, and G are perforated at the window and or ring areas.

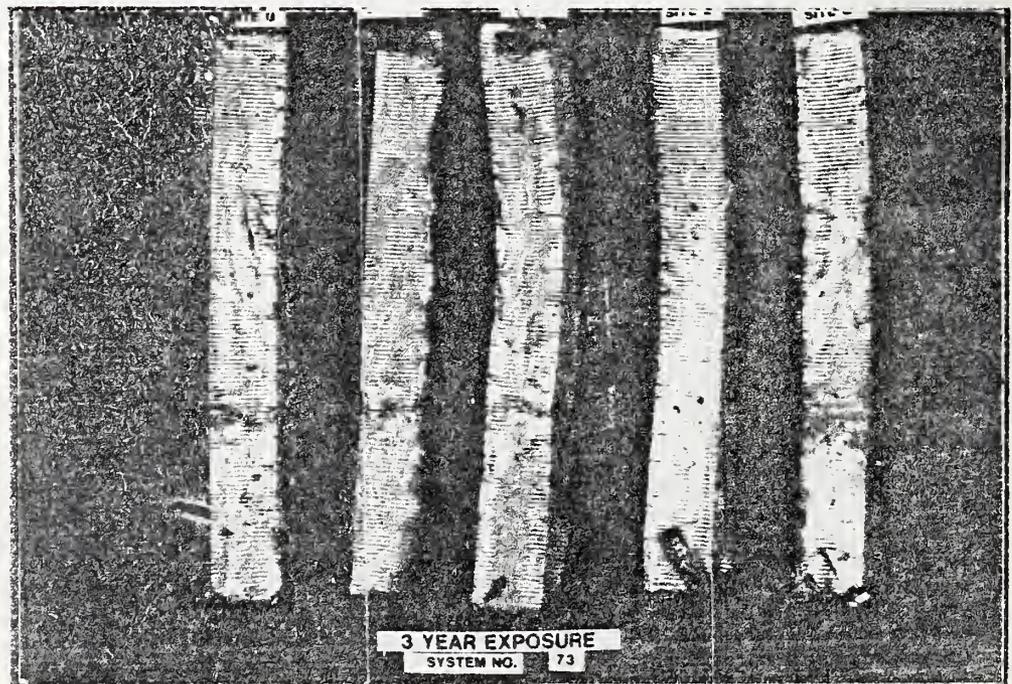
Figure 9. Inner Shield; System 73, Sites B,C,D,E, and G, left to right, exposed for three years. Severe degradation of the window and ring areas of the specimen from Site G.

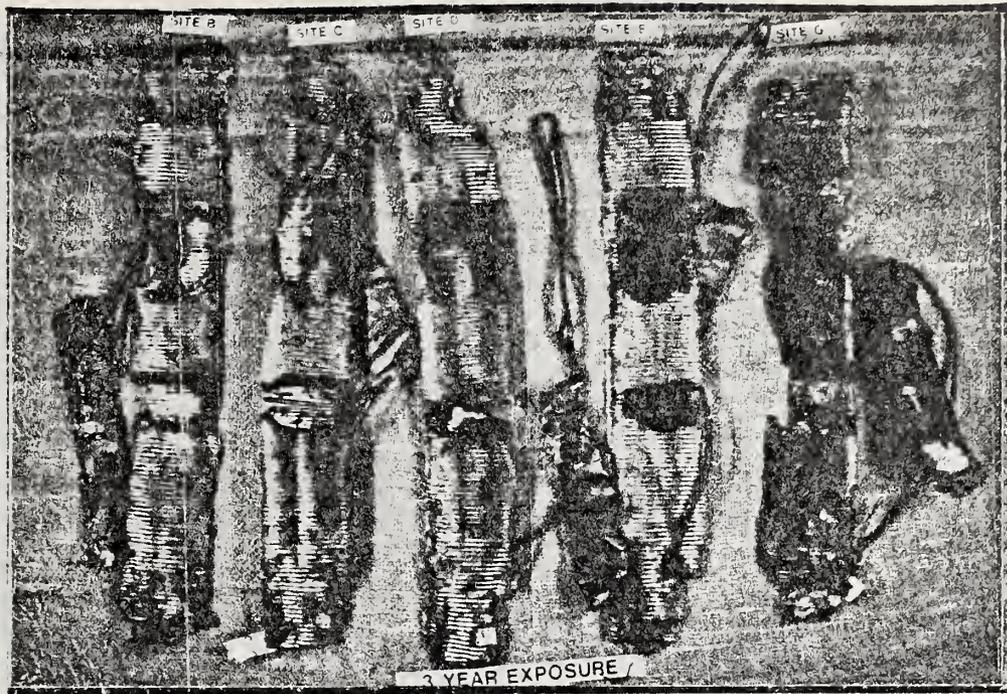
Coupling specimens of this system to copper accelerated corrosion of the shields at unjacketed areas. With few exceptions corrosion on the inner shields of specimens buried up to three years at all sites was nil or superficial. Specimens at Site B were ELD or near ELD for the first three years of exposure at the window and/or ring areas, while the adjacent window and ring areas were severely corroded. Severe degradation was noted at the window and/or ring areas exposed for one, two, and three years at Sites D and E. Of the specimens buried at Site G all areas examined on the inner shield were ELD after two and three years of exposure. The outer shield at the window area was ELD on specimens exposed at Site G for one,

Figure 10. Outer Shield; System 74, Sites B,C,D,E, and G, left to right, exposed for three years. Coupling this system to copper accelerated corrosion on all specimens.

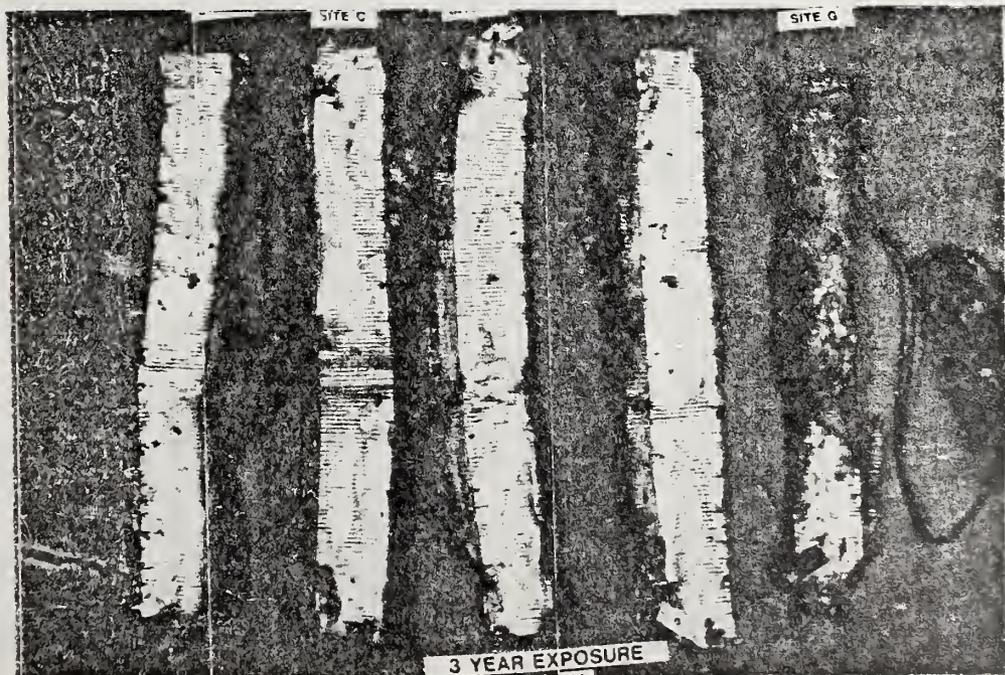
Figure 11. Inner Shield; System 74, Sites B,C,D,E, and G, left to right, exposed for three years. Coupling this system to copper accelerated corrosion on the specimen from Site G.

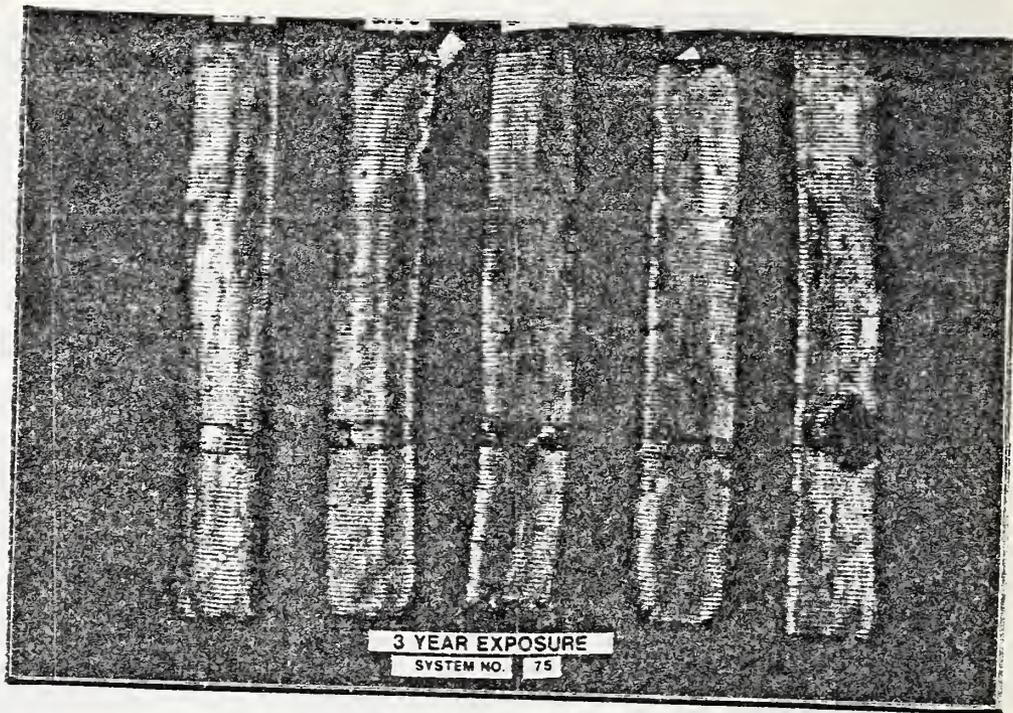
System 75. The inner aluminum alloy shield on specimens of this system (Table 1) exposed for up to three years at all sites was unaffected by corrosion. The outer steel shield on specimens buried at Sites C, E, and G for one year, Sites A and B for up to two years, and Site D for up to three years was also unaffected by corrosion. Corrosion was superficial or nil on specimens buried at Sites D and E for three years.

With one exception, corrosion at all areas examined on both shields was nil on specimens buried for one to three years at Site C. The outer shield exposure showed slight corrosion at all areas examined after two years of exposure at the same site. At Site G the window area was near ELD for the specimen buried for two years and near ELD at the ring area after three years exposure.

Figure 12. Outer Shield; System 75, Sites B,C,D,E, and G, left to right, exposed for three years. Dark areas indicate corrosion on the specimens.

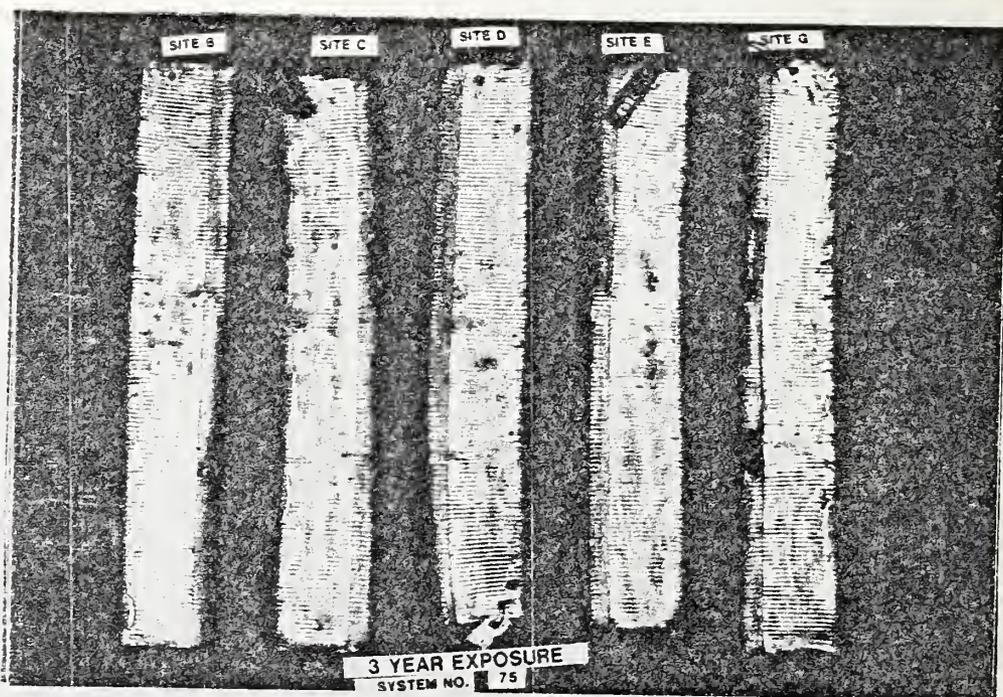
Figure 13. Inner Shield; System 75, Sites B,C,D,E, and G, left to right, exposed for three years. Corrosion was not apparent.

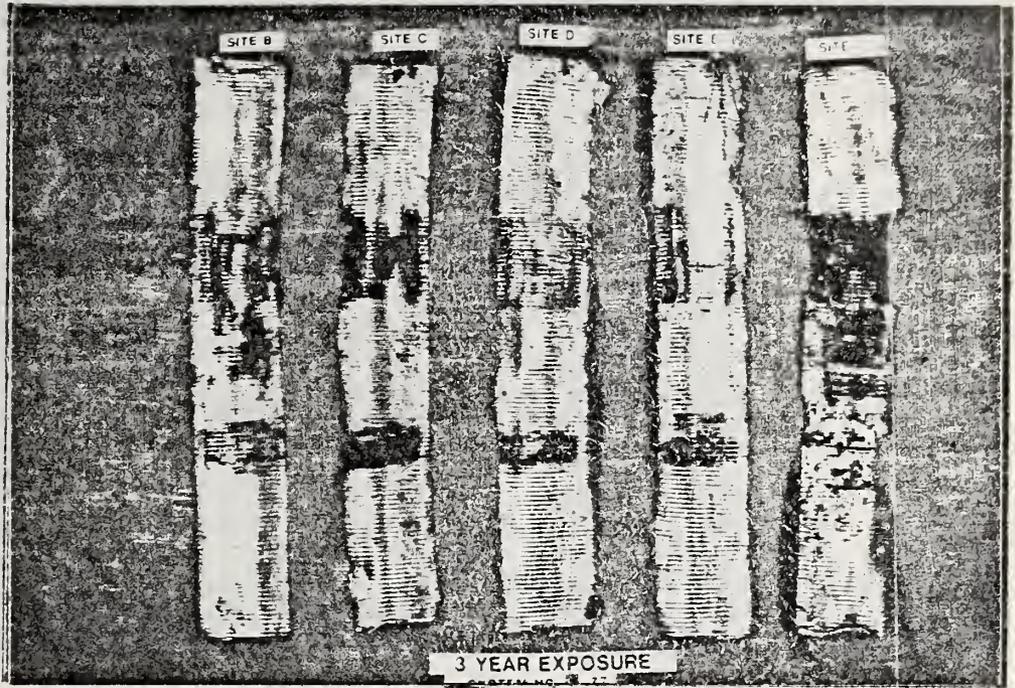
System 77. The aluminum alloy inner shield on specimens of this system (Table 1) were unaffected by corrosion after exposure for up to three years in all soils with the exception of one specimen at Site G. There was no degradation of the outer steel shield of specimens buried for one year at Sites A, B, and D. After exposure for three years, corrosion of the outer shield was superficial or nil at jacketed areas for all specimens except for those exposed at Sites B and C. Corrosion of the outer shield was observed at the window and ring areas of all specimens buried for two and three years in all soils. Perforation due to localized pitting corrosion was noted at window and ring areas on specimens buried at Sites A and D for two years and at Sites B, C, and E for up to three years on the outer shield. The specimens exposed at Site G for two and three years were ELD at and adjacent to the window and/or ring areas.

Figure 14. Outer Shield; System 77, Sites B,C,D,E, and G, left to right, exposed for three years. Severe corrosion at the window and ring areas of the specimen from Site G.

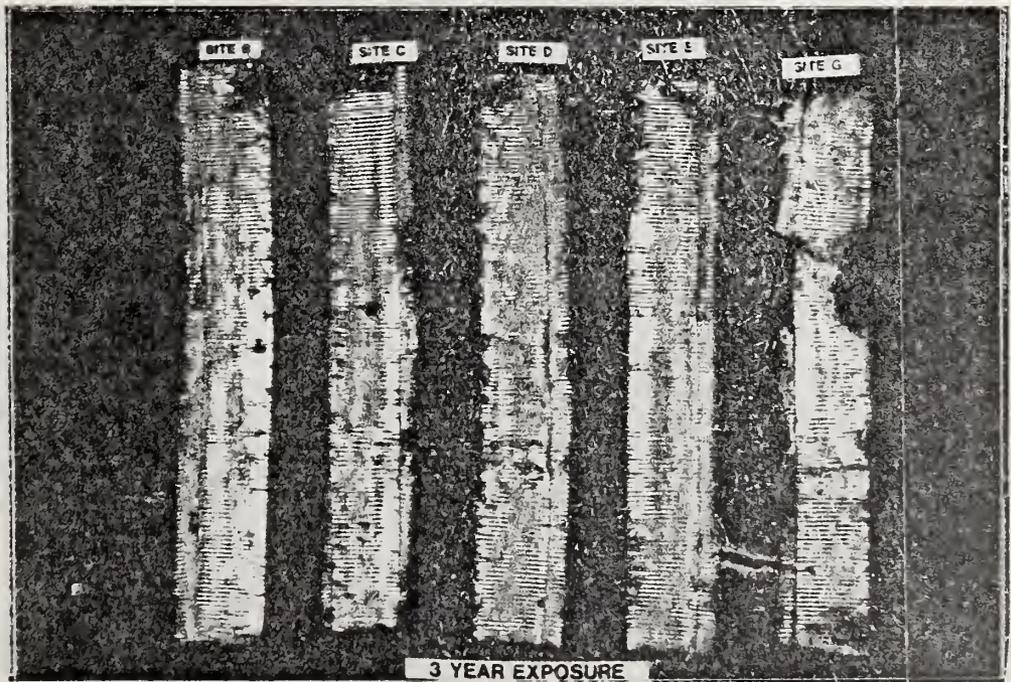
Figure 15. Inner Shield; System 77, Sites B,C,D,E, and G, left to right, exposed for three years. Degradation at the window area of the specimen from Site G.

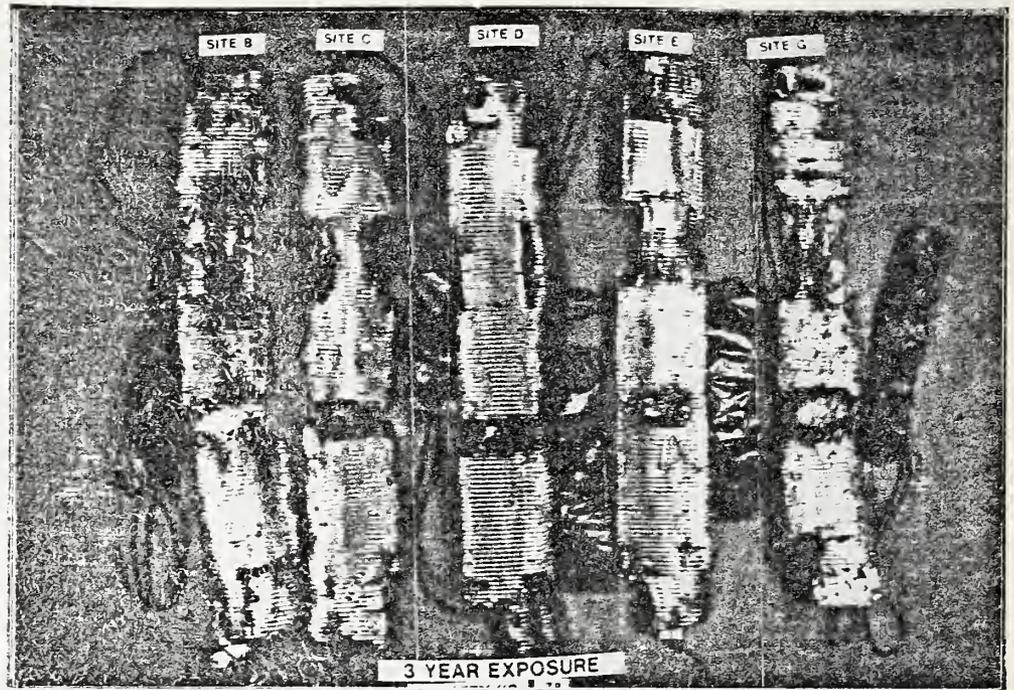
Coupling the shields to copper accelerated corrosion of the outer shield in all of the soils and of the inner shield at Sites C and G. The inner shields of specimens buried for three years at Sites B and D were unaffected by corrosion. Corrosion of the inner shield on specimens buried at Sites C and G occurred at the window and/or ring areas. For specimens buried at Site G for up to three years, the inner shield was ELD or near ELD at window and ring areas and severely corroded at jacketed areas. In general, severe corrosion was observed on the outer shield at the window and ring areas on all specimens of this system. Of the specimens buried for two and three years at Sites B, C, and G, the outer shield was at or

near ELD at the unjacketed window and ring areas. Corrosion of the outer shield was severe at the window and ring areas on specimens of this system buried for two years at Sites A and D and three years at Site E.

Figure 16. Outer Shield; System 78, Sites B,C,D,E, and G, left to right, exposed for three years. Coupling this system to copper accelerated corrosion at the window and ring areas on all specimens.

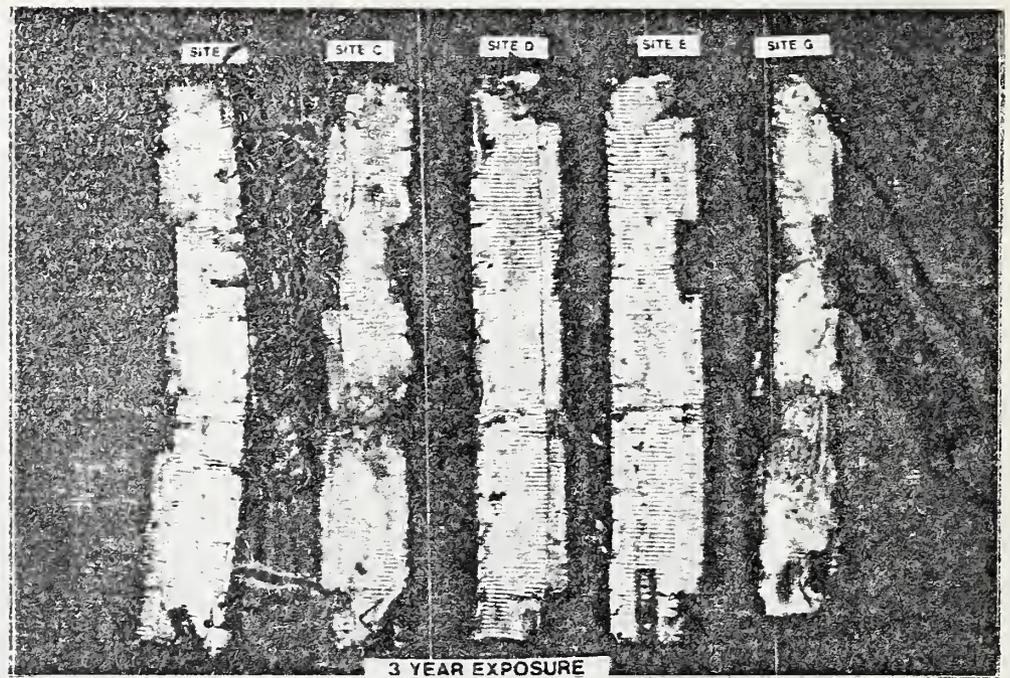
Figure 17. Inner Shield; System 78, Sites B,C,D,E, and G, left to right, exposed for three years. Coupling this system to copper accelerated corrosion at Sites C and G.

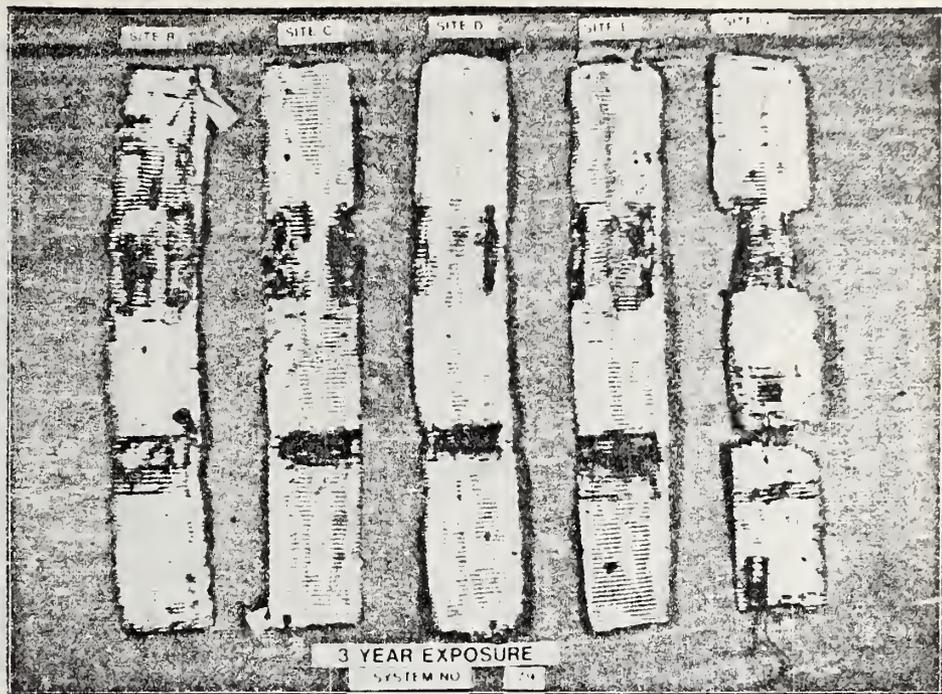
System 79. Except for the specimens of this system (Table 1) buried at Site G, there was no degradation of the inner aluminum alloy shield on any of the specimens buried up to three years. Severe corrosion was noted on the inner shield at the window and ring areas on specimens exposed for up to three years at Site G. In general, corrosion of the outer steel shield occurred at or adjacent to the unjacketed window and ring areas. Perforation due to corrosion at the jacketed and adjacent window areas was observed after exposure for one year at Site E. At the same site, the window and ring areas on the outer steel shield were perforated due to corrosion for specimens exposed for two and three years. The specimen buried for up to three years at Site G was at or near ELD at or adjacent to window and ring areas.

Figure 18. Outer Shield; System 79, Sites B,C,D,E, and G, left to right, exposed for three years. Dark areas indicate corrosion on specimens with severe corrosion on the specimen from Site G at window and ring areas.

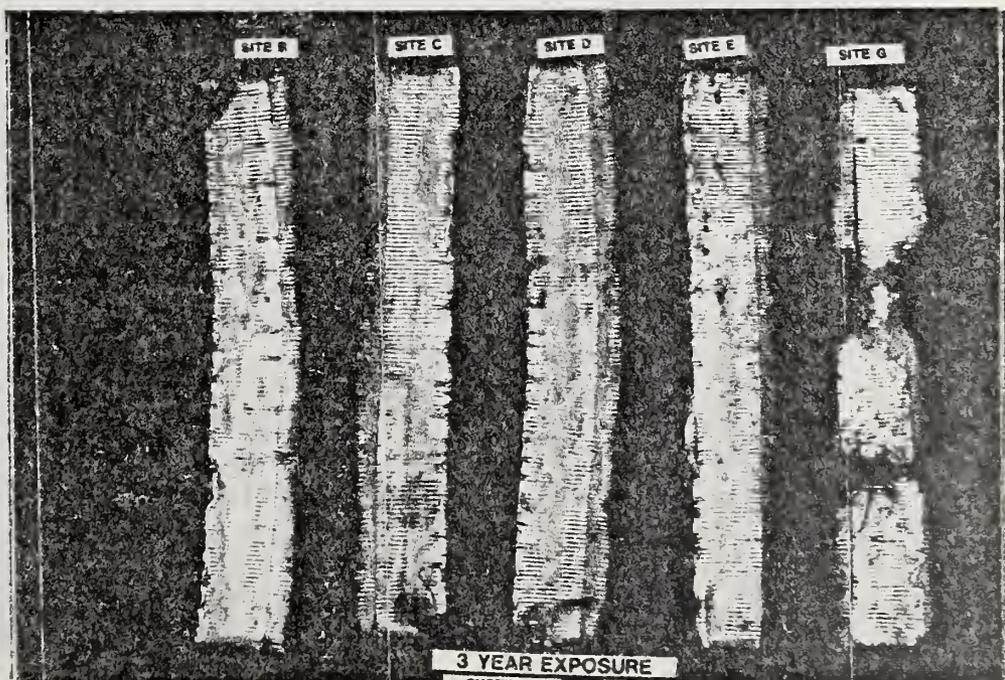
Figure 19. Inner Shield; System 79, Sites B,C,D,E, and G, left to right, exposed for three years. Severe degradation at the window and ring areas on the specimen from Site G.

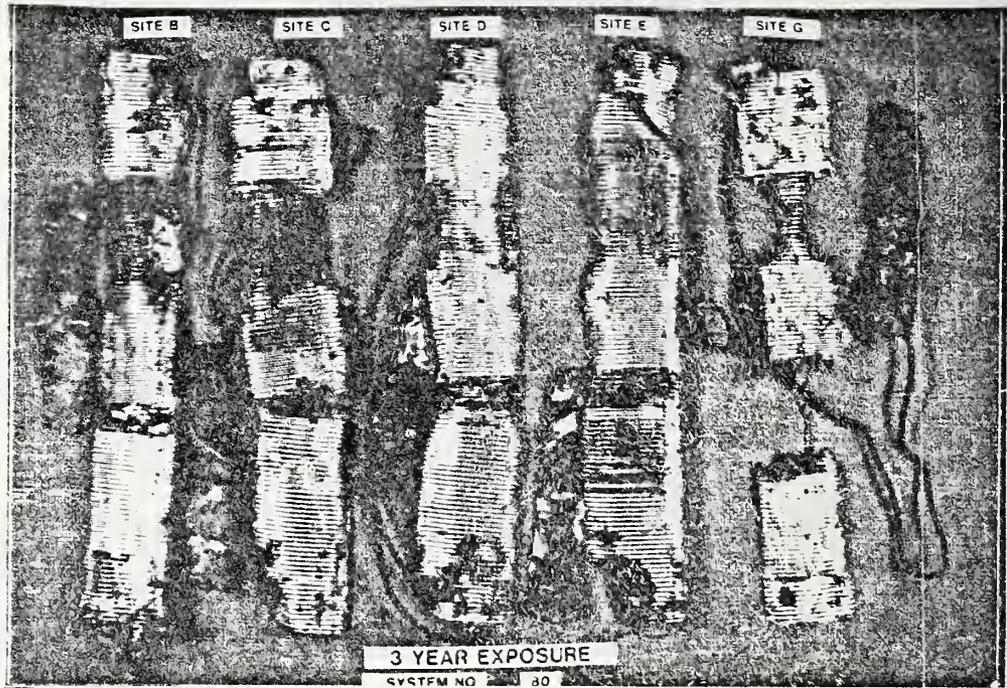
Coupling specimens of this system to copper accelerated corrosion of the shields. With a few exceptions, there was little or no corrosion on either shield at jacketed areas of specimens buried at Sites A and C for two years and Sites D and E for three years. The inner aluminum alloy shield was perforated due to corrosion at unjacketed window and ring areas on specimens buried up to three years at all sites. Specimens exposed for three years at Sites B, C, and G were ELD at the window and ring areas on

Figure 20. Outer Shield; System 80, Sites B,C,D,E, and G, left to right, exposed for three years. Coupling this system to copper accelerated corrosion at the window and ring areas on all specimens.

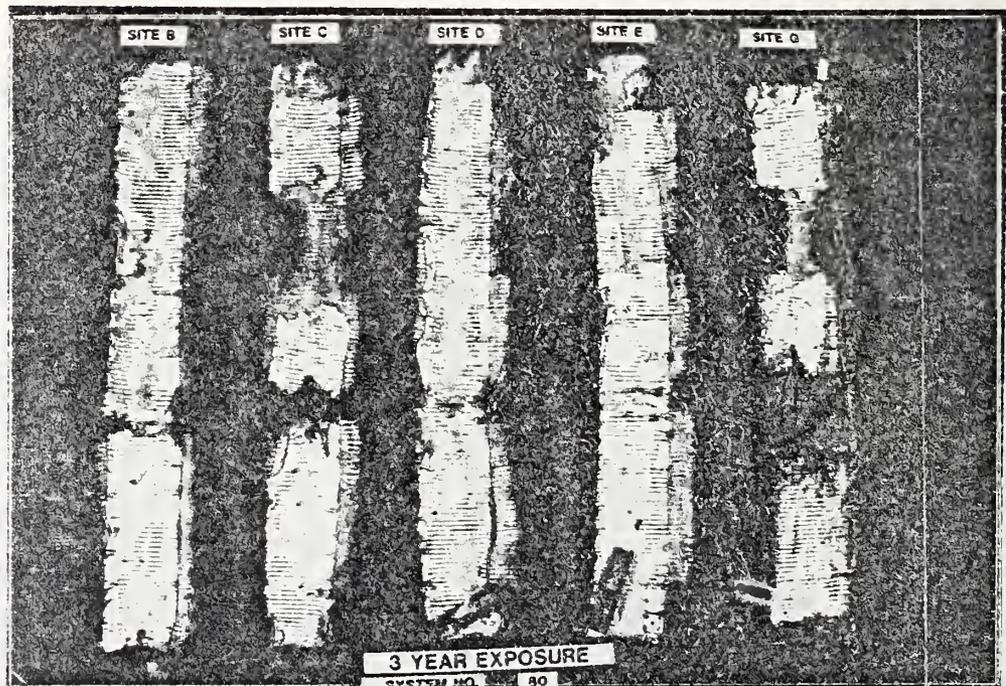
Figure 21. Inner Shield; System 80, Sites B,C,D,E, and G, left to right, exposed for three years. Coupling this system to copper accelerated degradation at the window and ring areas on specimens from Sites B,C, and G.

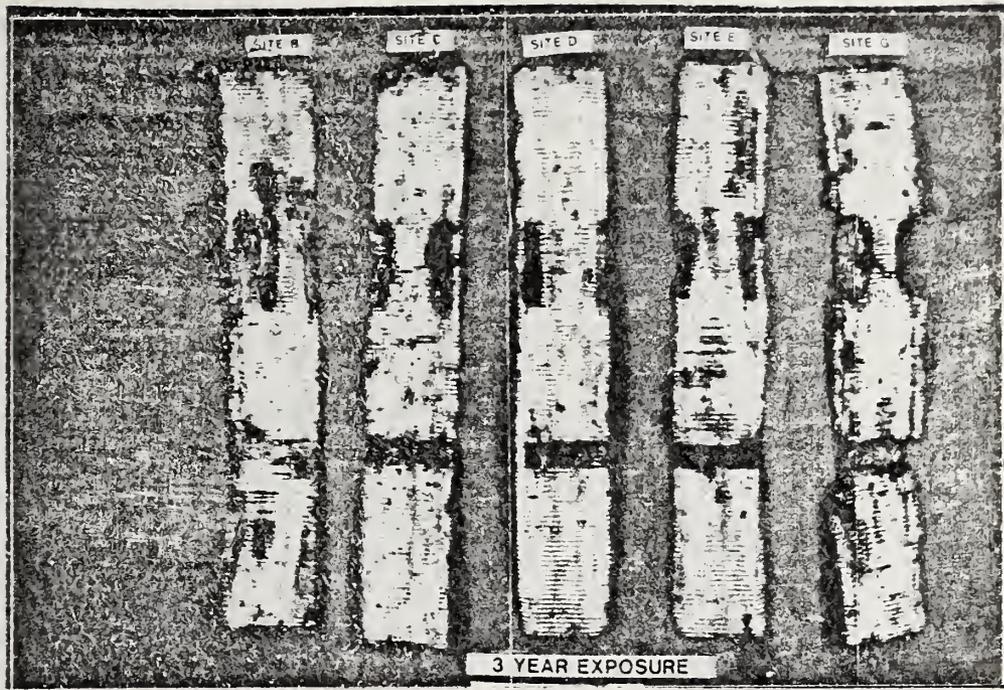
System 81. There was no corrosion of the inner aluminum alloy shield for specimens of this system (Table 1) after exposure for one and two years at Sites A and G and up to three years at Sites B, C, D, and E. Corrosion of the steel outer shield in varying degrees was noted at unjacketed window and/or ring areas of specimens exposed up to three years at Sites B, C, D, and E. The inner and outer shields at the unjacketed window and ring areas of the specimens were ELD after the third year of exposure at Site G. However, only the inner shield was ELD at the adjacent ring after the same amount of time.

Figure 22. Outer Shield; System 81, Sites B,C,D,E, and G, left to right, exposed for three years. Dark areas indicate corrosion on specimens with severe corrosion at the window and ring areas on the specimen from Site G.

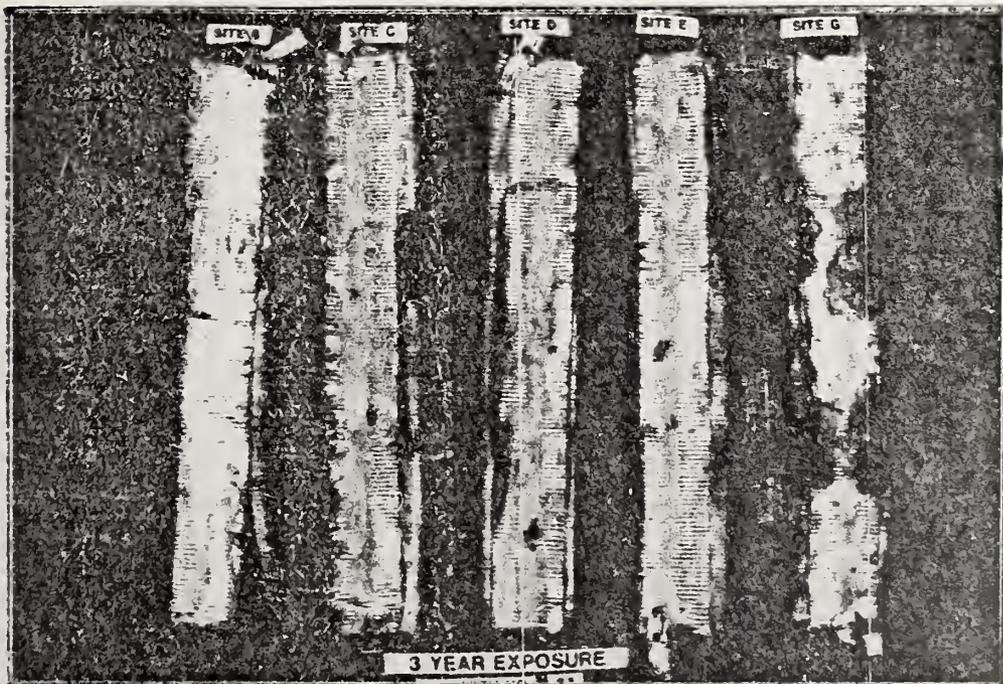
Figure 23. Inner Shield; System 81, Sites B,C,D,E, and G, left to right, exposed for three years. Severe degradation on the specimen from Site G.

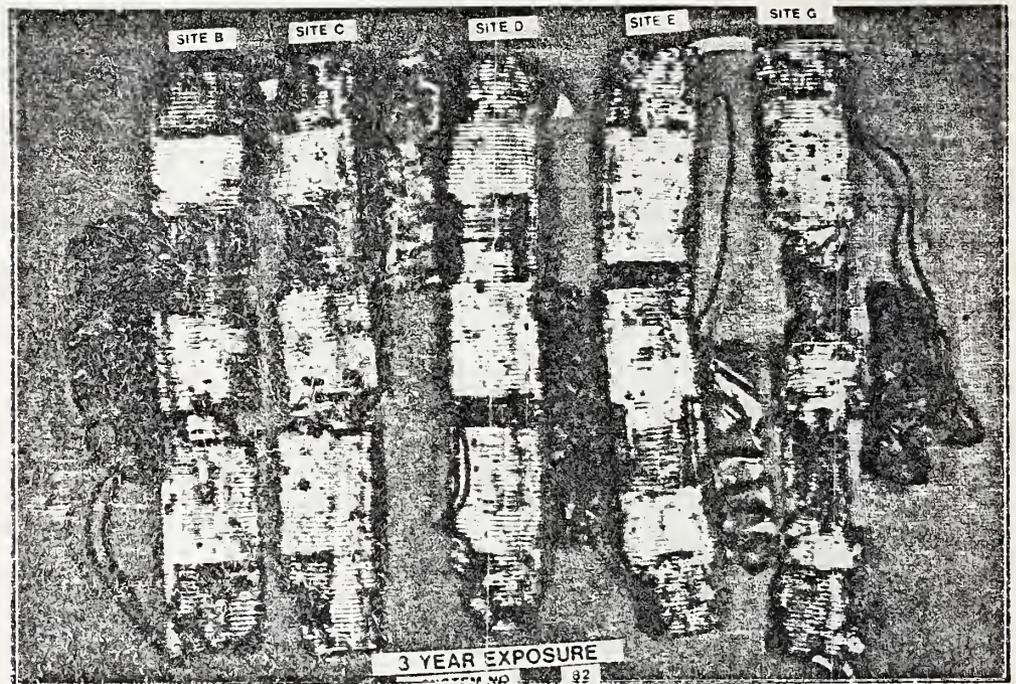
Coupling specimens of this system to copper accelerated corrosion of the outer steel shield at window and ring areas in all of the soils. The inner and outer shields at jacketed areas exhibited little or no corrosion after exposure at Sites A and B for up to two years and at Sites C, D, and E for up to three years. Severe corrosion was observed on the outer steel shield at the window and/or ring areas of specimens buried at Site A for two years and at Sites D and E for up to three years. The outer shield at the window and ring areas was severely corroded after exposure of one year at Site B as were the adjacent window and ring areas of the outer shield after exposure for three years. Specimens buried for two and three years

Figure 24. Outer Shield; System 82, Sites B,C,D,E, and G, left to right, exposed for three years. Coupling this system to copper accelerated corrosion on the specimens from Sites C and G severely.

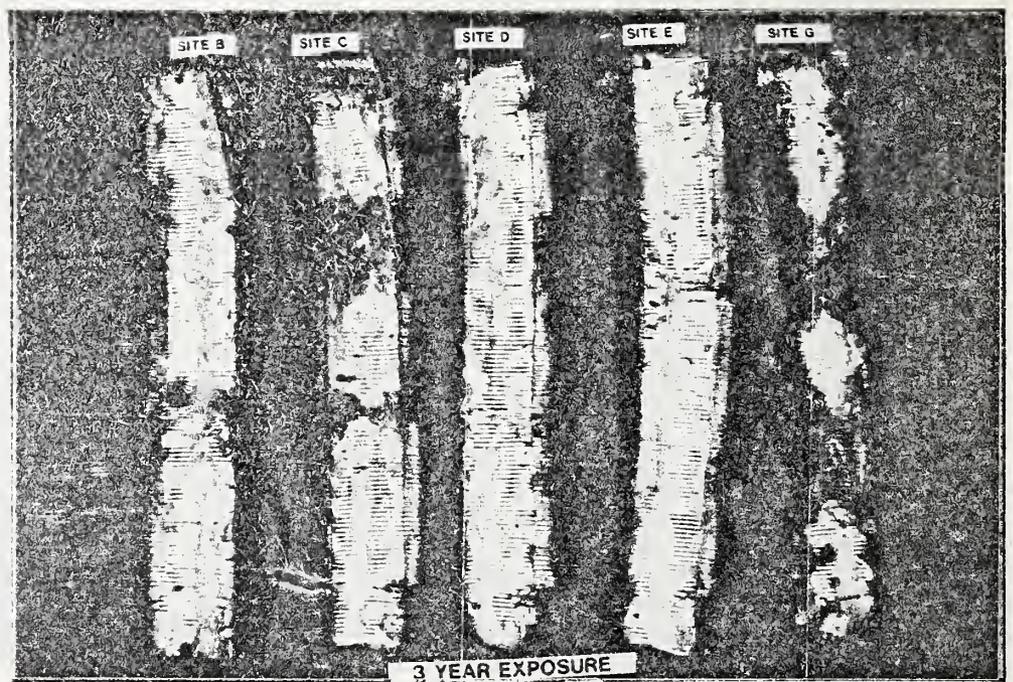
Figure 25. Inner Shield; System 82, Sites B,C,D,E, and G, left to right, exposed for three years. Coupling this system to copper accelerated corrosion on the specimens from Sites B,C, and G.

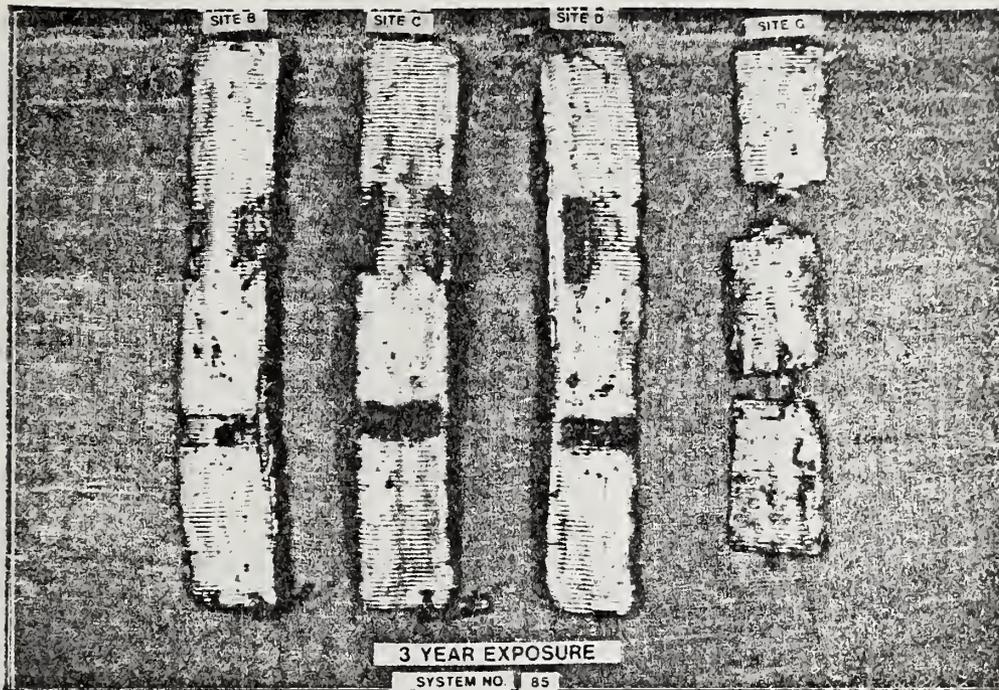
Figure 26. Outer Shield; System 85, Sites B,C,D, and G, left to right, exposed for three years. Dark areas indicate corrosion on the specimens with severe corrosion on the specimen from Site G at the window and ring areas.

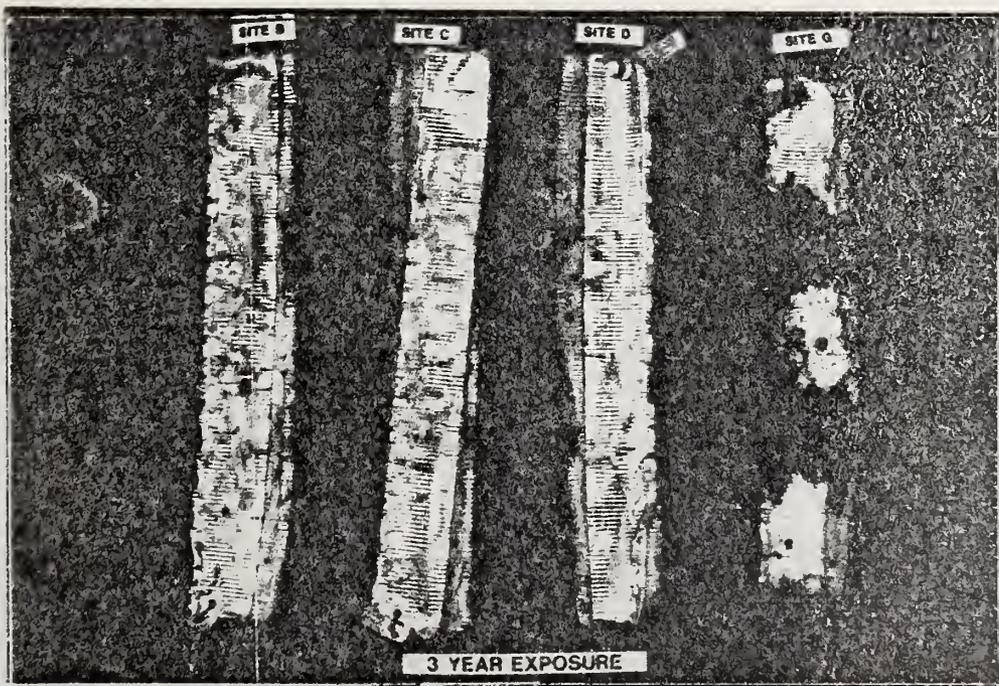
Figure 27. Inner Shield; System 85, Sites B,C,D, and G, left to right, exposed for three years. The specimen from Site G was severely corroded.

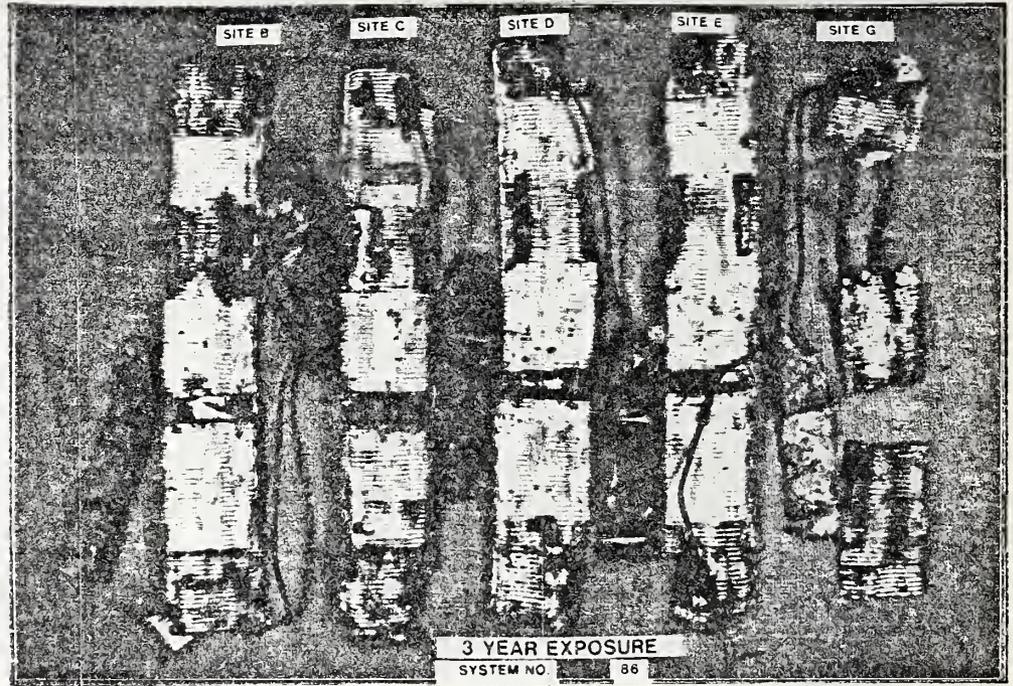
Figure 28. Outer Shield; System 86, Sites B,C,D,E, and G, left to right, exposed for three years. Coupling this system to copper accelerated corrosion at most examined areas on all specimens.

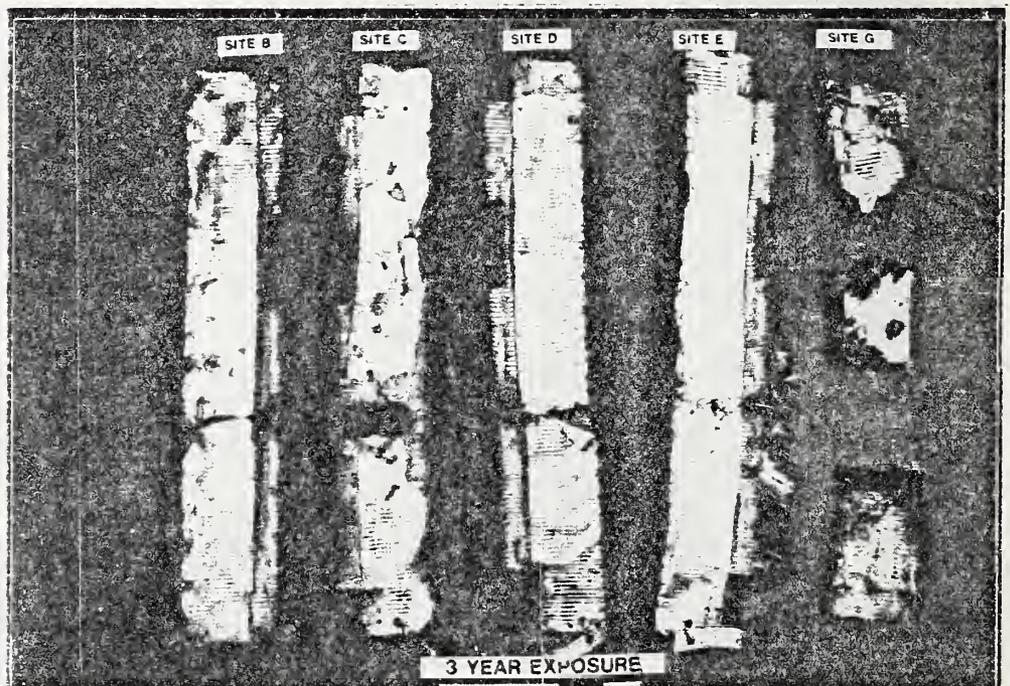
Figure 29. Inner Shield; System 86, Sites B,C,D,E, and G, left to right, exposed for three years. Coupling this system to copper accelerated degradation on most specimens with severe degradation on the specimen from Site G.
